Manhole Inspection Summary

Manhole # S49AA_028MH

Insp Date: **5/8/08 10:49 AM**

Location Address: **600 n lakewood ave**

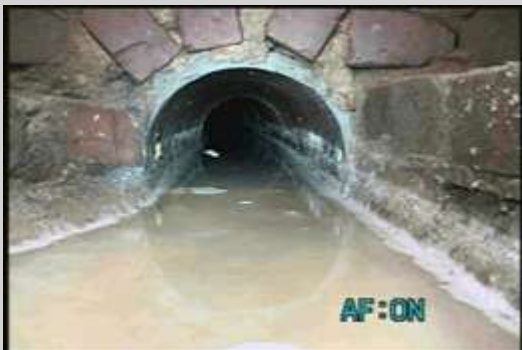
12 O'Clock Outflow

8 in. Circular Gravity Sewer
Pipe Out @ 12 O'Clock

Invert Depth: **5.66** (ft.) Flow Characteristics: **Fast**

Deposits: ☒ None ☐ Mud ☐ Sludge ☐ Debris ☐ Grease

Infiltration: **None** Pipe Seal Cond: **Unknown**

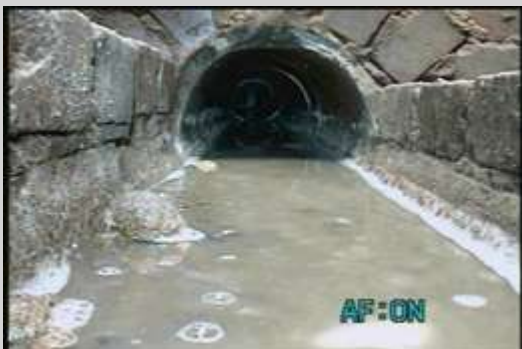
6 O'Clock Inflow

10 in. Circular Gravity Sewer
Pipe In @ 6 O'Clock

Invert Depth: **5.34** (ft.) Flow Characteristics: **Fast**

Deposits: ☒ None ☐ Mud ☐ Sludge ☐ Debris ☐ Grease

Infiltration: **None** Pipe Seal Cond: **Unknown**

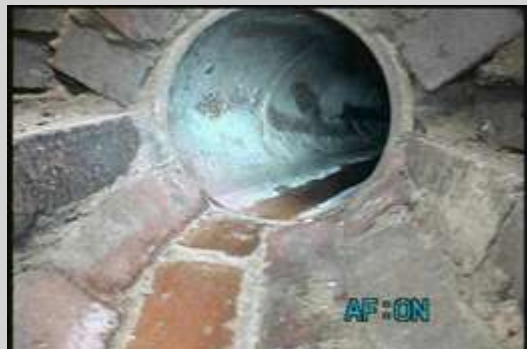
9 O'Clock Inflow

8 in. Circular Gravity Sewer
Pipe In @ 9 O'Clock

Infiltration: **None** Pipe Seal Cond: **Unknown**
